Manhole Inspection Summary

Manhole # S37EE_066MH

Insp Date: **3/22/07 12:59 PM**

Location Address: **439 PRESTON ST**

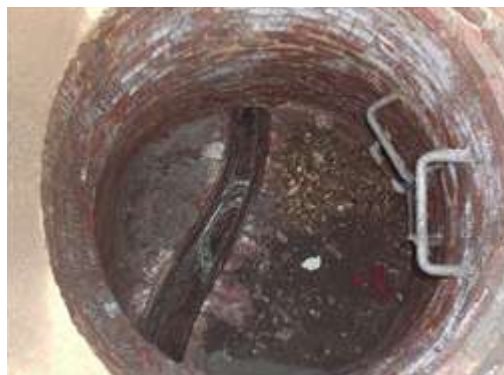
Top View

Evidence of surcharge - Bench debris.
Corroded steps.

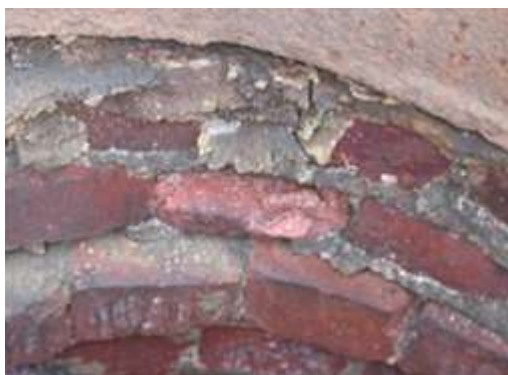
Defect

Frame leaks. Adjustment deterioration and infiltration. Corbel infiltration.

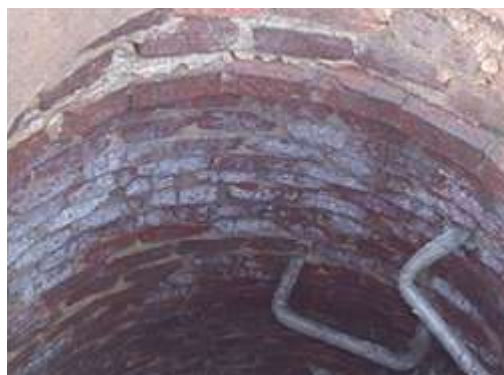
Defect

Frame leaks. Adjustment deterioration and infiltration. Corbel and Barrel infiltration.

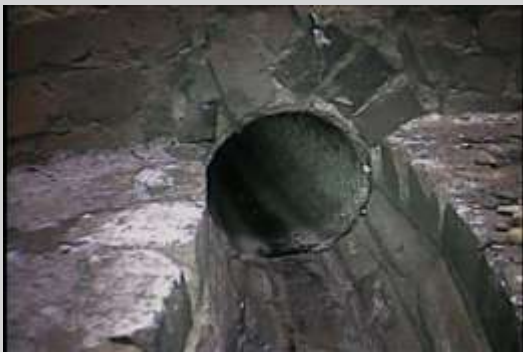
8 in. Circular Gravity Sewer Pipe Out @ 12 O'Clock

Infiltration: **None** Pipe Seal Cond: **Unknown**

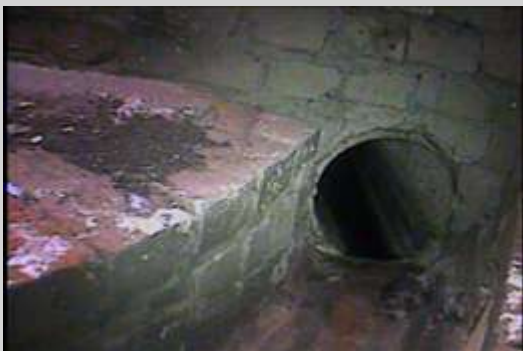
8 in. Circular Gravity Sewer Pipe In @ 6 O'Clock

Infiltration: **Evidence** Pipe Seal Cond: **Cracked**
